Manhole Inspection Summary

Manhole # S21GG_013MH

Location Address: **1700 BAKER ST**

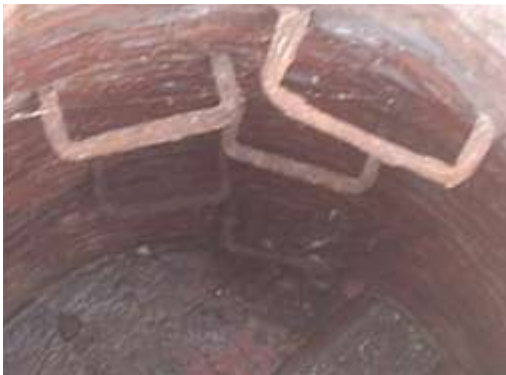
Defect 3

Count: **5** Missing: **1** ☒ **Corroded**

CORRODED STEPS

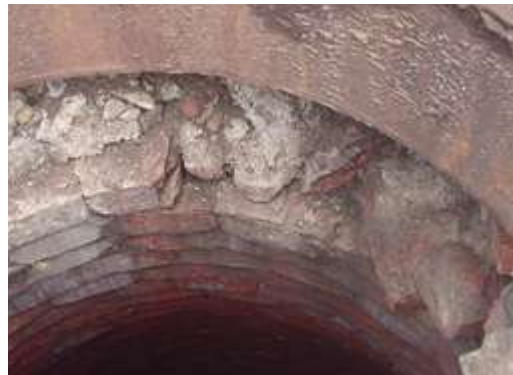
Defect 2

Condition: ☐ Sound ☐ Cracked ☐ Root Intrusion ☐ Loose Brick ☒ **Deteriorated**

DETERIOATION OF CHIMNEY

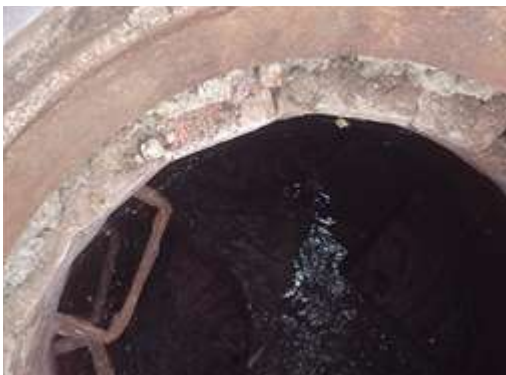
Defect 1

Offset: **2** (in.)

FRAME OFFSET

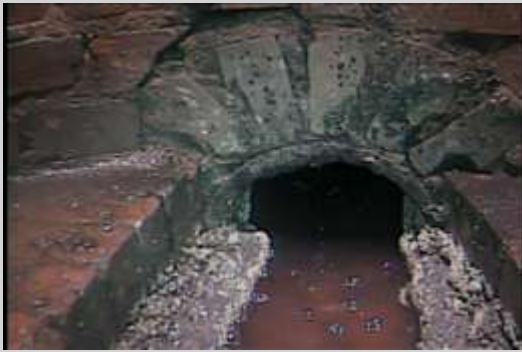
6 O'Clock Inflow

Deposits: ☐ None ☐ Mud ☐ Sludge ☐ Debris ☒ Grease

Silt Depth: **2** (in.) Deposits Extent: **Light**

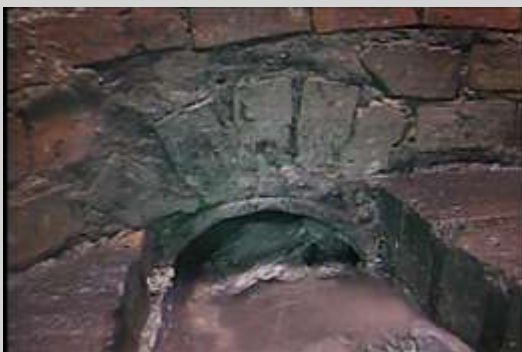
9 O'Clock Inflow

Deposits: ☐ None ☐ Mud ☐ Sludge ☒ Debris ☐ Grease

Silt Depth: **3** (in.) Deposits Extent: **Medium**
